COMMONWEALTH OF KENTUCKY  
BEFORE THE PUBLIC SERVICE COMMISSION

KENTUCKY UTILITIES COMPANY	)	
	)	
AND	)	
	)	
SOUTH CENTRAL RURAL TELEPHONE	)	CASE NO.
COOPERATIVE CORPORATION	)	90-257
	)	
	)	
	)	
_____	)	
	)	
ALLEGED FAILURE TO COMPLY	)	
WITH COMMISSION REGULATIONS	)

ORDER TO SHOW CAUSE

ELECTRICAL UTILITY ACCIDENT INVESTIGATION

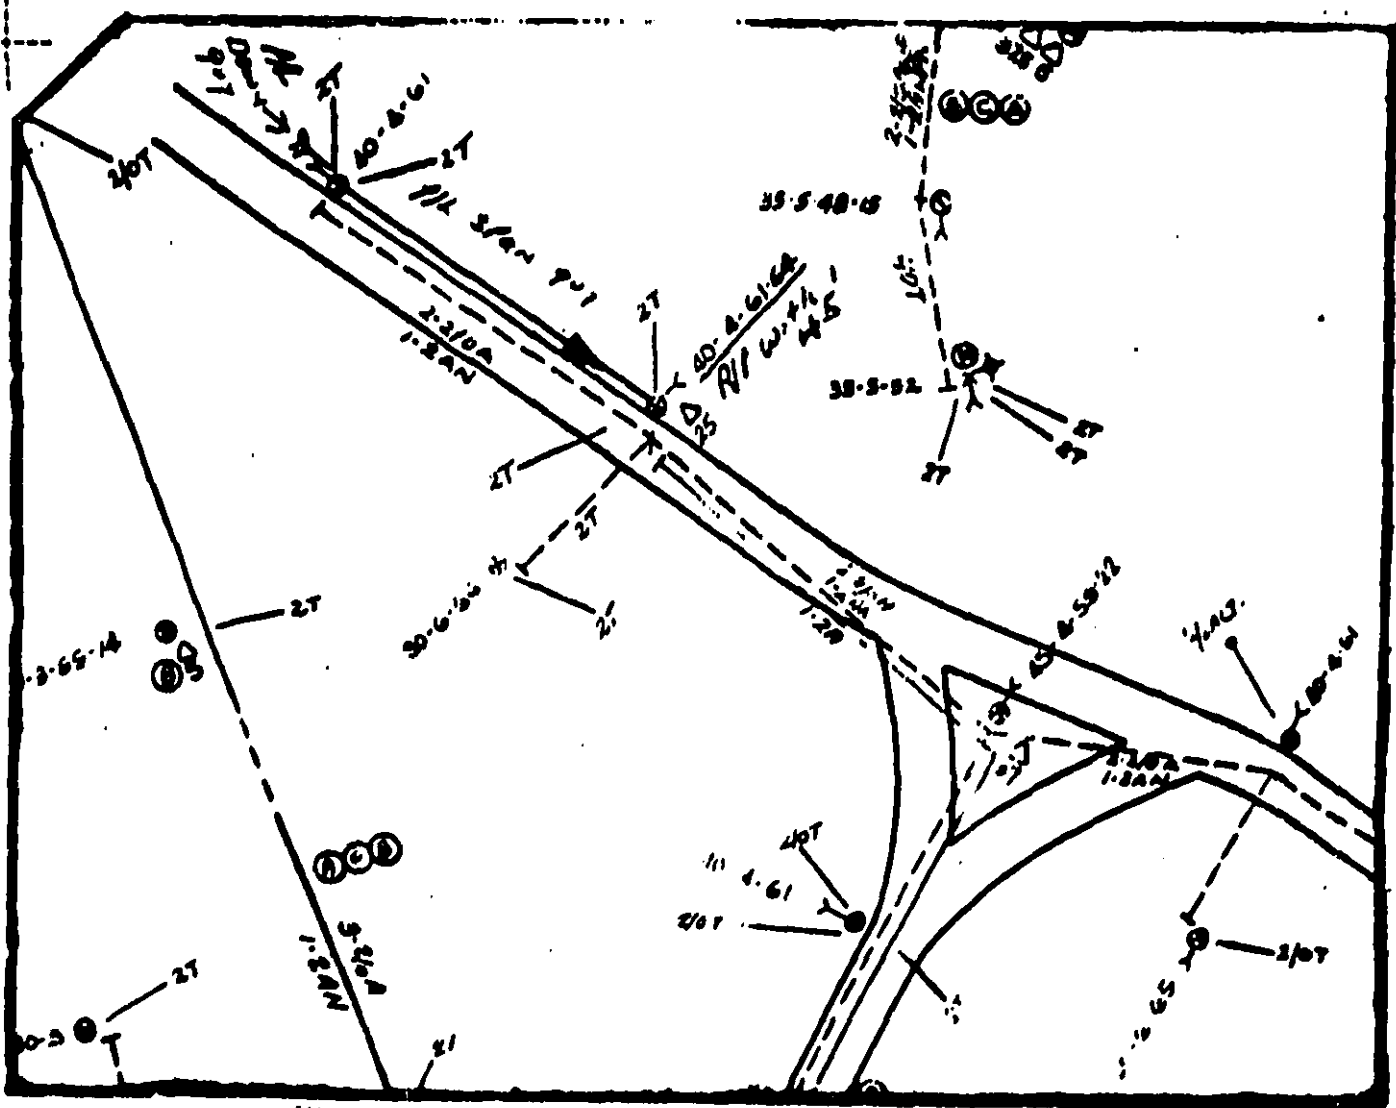
Location of Work North End of Washington St. MurderkillReason Needed low clearance over st.Description of Work RIP 40' pole with 45' x 40' Span 9x1
